Thorn Run Dam, NDI Number PA-271.
Ohio River Basin, Thorn Creek, Butler County,
Pennsylvania. Phase I Inspection Report.

PHASE I REPORT
National Dam Inspection Program

Thorn Run Dam

31 August 1978 and 5 September 1978

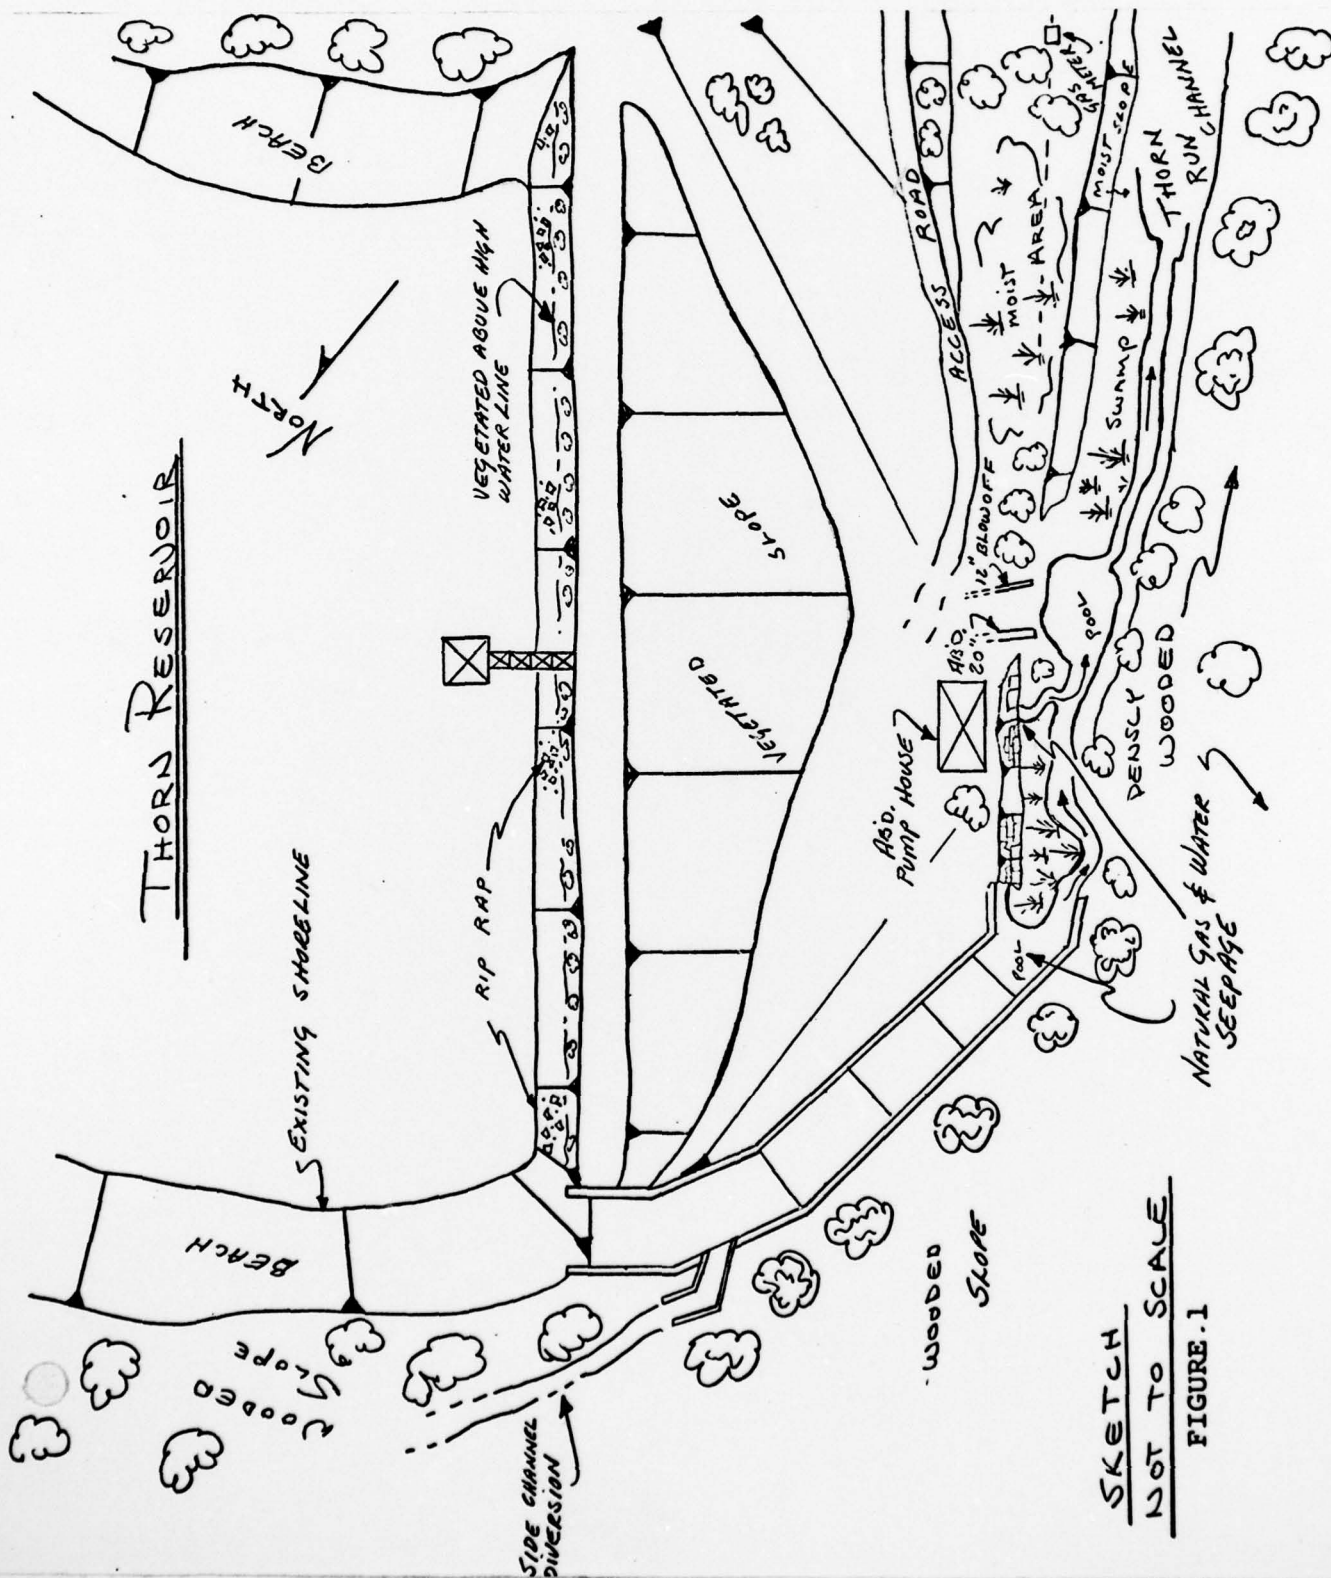
SKETCH
NOT TO SCALE
FIGURE.1

Although the spillway has reportedly not discharged in recent weeks, a significant pool of water is visible at its discharge end. According to the available drawings (see Figure 2), the discharge end of the spillway is designed such that a small pool is normally impounded in this area, apparently to act as a stilling basin. However, the amount of water observed at the time of inspection appeared to be excessive (see Photograph 10). Less than 20 feet beyond the pool a definite flow was observed indicating that some seepage was emanating from the pool area. A small seep (less than 5 GPM) was located directly behind and below the old booster station approximately level with the stream surface. Upon further examination of this seep, gas bubbles were observed issuing from below the water level. Upon re-examining the pool area at the end of the spillway, gas bubbles were also observed from several different areas within this pool (see Figure 1). The nature or origin of the gas could not be readily ascertained.

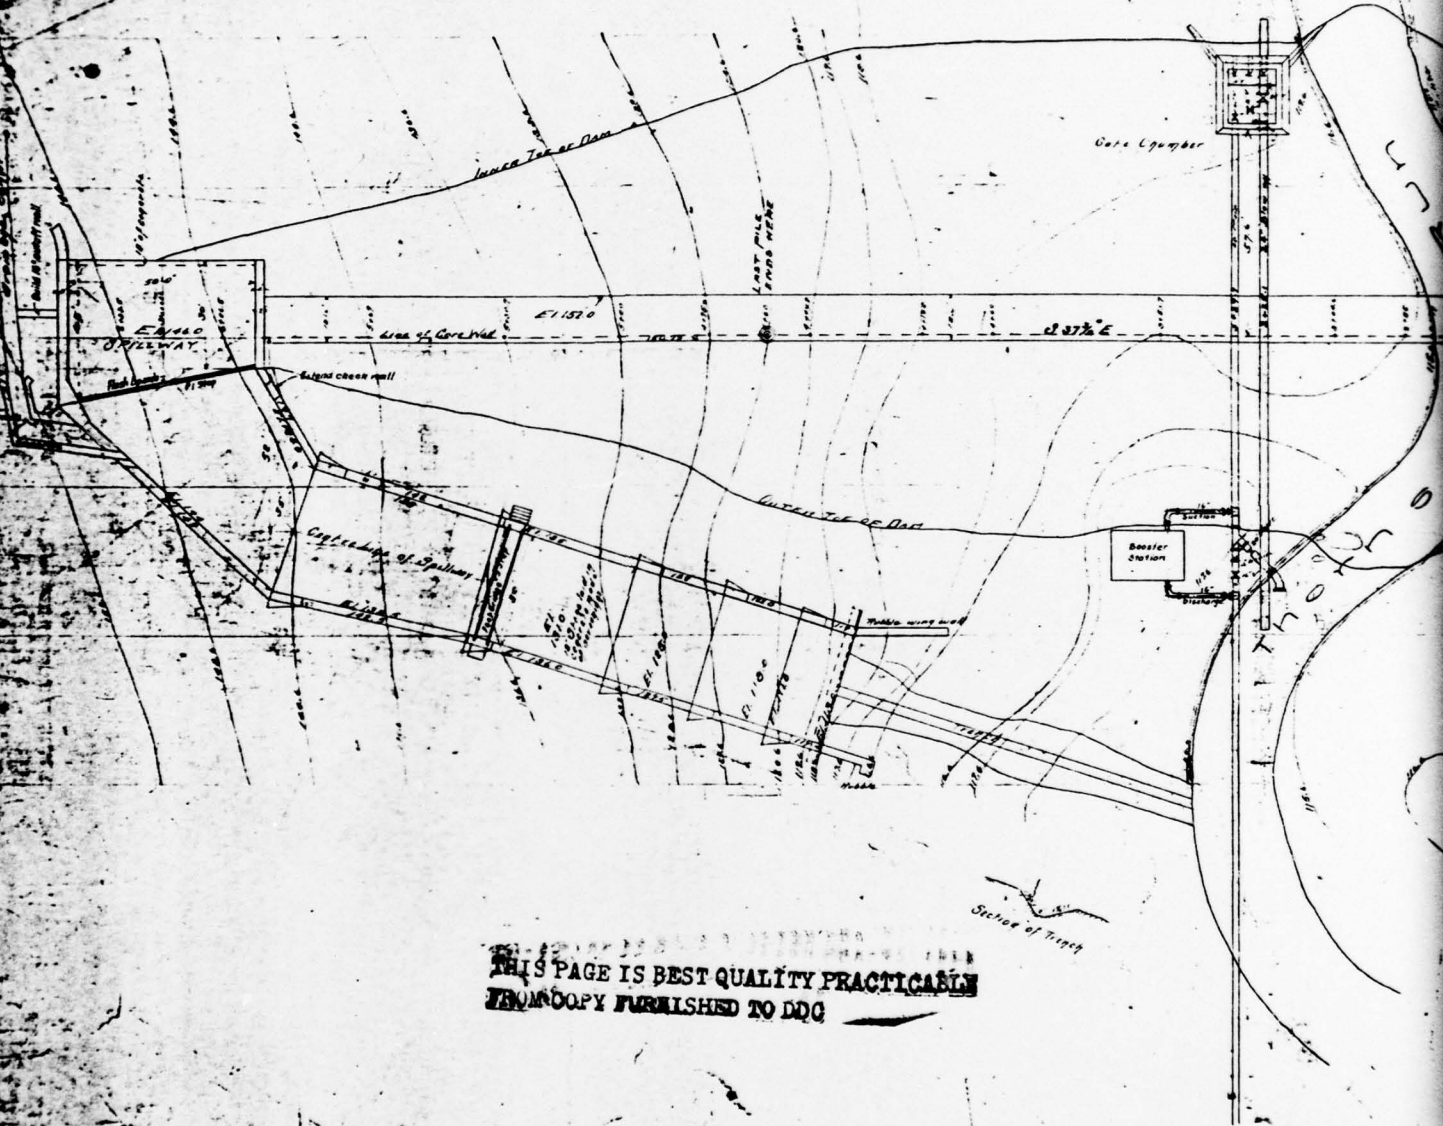
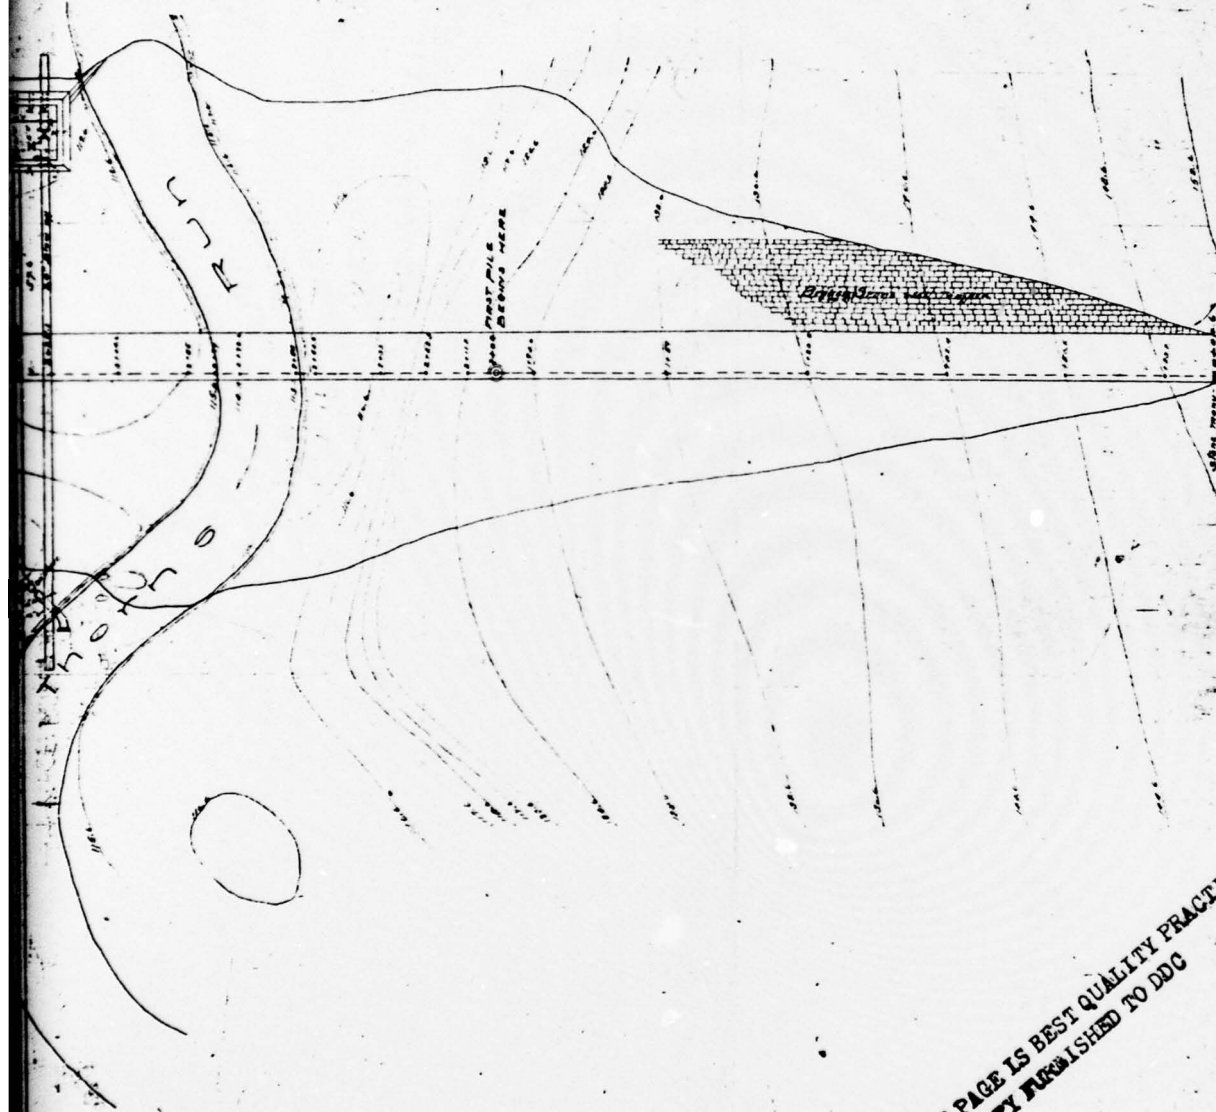
FIGURE 2

The drawings show the embankment was designed with a 2H on 1V upstream slope, a 1.5H on 1V downstream slope, and a 12.5 foot wide crest (see Figures 2 and 3, note comments in Section 3.1.b).

collects runoff from a dairy farm located along the right abutment hillside (see Figures 2 and 3).

Figure 2 shows a booster station structure located at the base of the downstream toe. This masonry structure housed pumping equipment used to supplement the pumping capabilities of the water supply system located at the treatment plant. The booster station was not part of the original design. It was constructed in 1940, many years after the project had been completed and remained in operation until the system was modified and is presently non-functional.

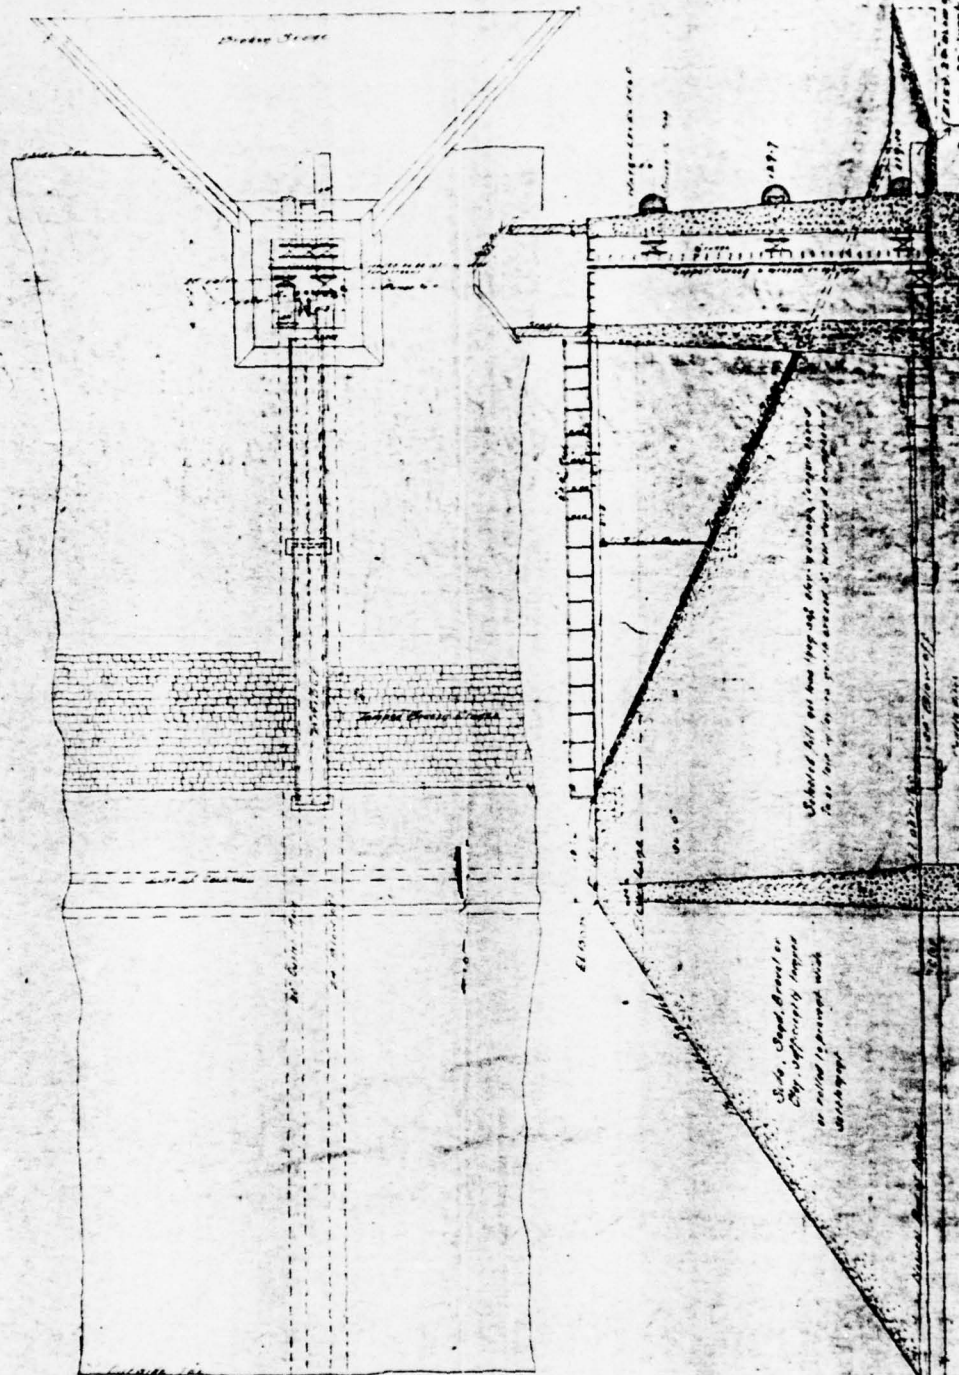
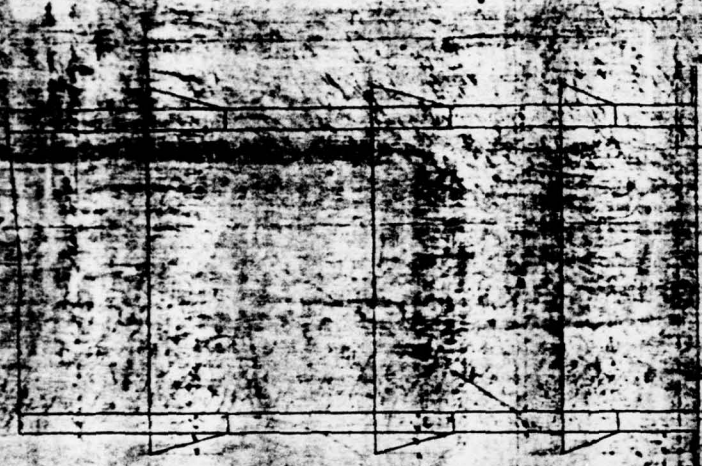
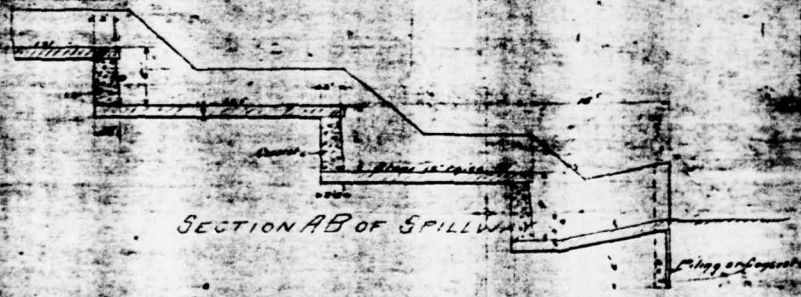
FIGURE 3

Zoning - Figure 3 indicates the embankment to be comprised of two zones separated by a concrete core wall located several feet downstream of the embankment centerline. The upstream zone is apparently composed of selected fill of not less than 30 percent clay. The drawings indicate the downstream zone is composed of a more pervious material; that is, a mixture of sods, sand, gravel and clay.

Impervious Core - Available drawings indicate a concrete core wall extends across the embankment and into both abutments. It was designed to be 24 inches thick at the top increasing to a thickness of 5 feet at its base. The maximum height of the wall is approximately 38 feet with the top reportedly located 5 feet below the crest and the base located 5 feet into the natural ground surface (see Figure 3).

b) Outlet Conduit. The outlet works shown on Figure 3 has since been modified and is no longer an accurate representation of the system. The original design called for a 24-inch diameter cast-iron blowoff pipe and a 20-inch diameter cast-iron service main. The lines were to be laid near the center of the embankment, surrounded with clay and constructed with concrete piers surrounding each joint (see Figure 3). When the system was modified (date of which is not known) the 24-inch diameter blowoff pipe was extended to the treatment plant and now also serves as a supply line. Blowoff and drawdown capabilities are provided by a 12-inch pipe connected to the 24-inch diameter supply line and valved at the downstream toe. In addition, the flow in the 20- and 24-inch diameter supply line can be regulated at the treatment plant downstream.
